NASA
Technical Memorandum 86881

Experimental and Analytical Study of Ceramic-Coated Turbine-Tip Shroud Seals for Small Turbine Engines

January 1985

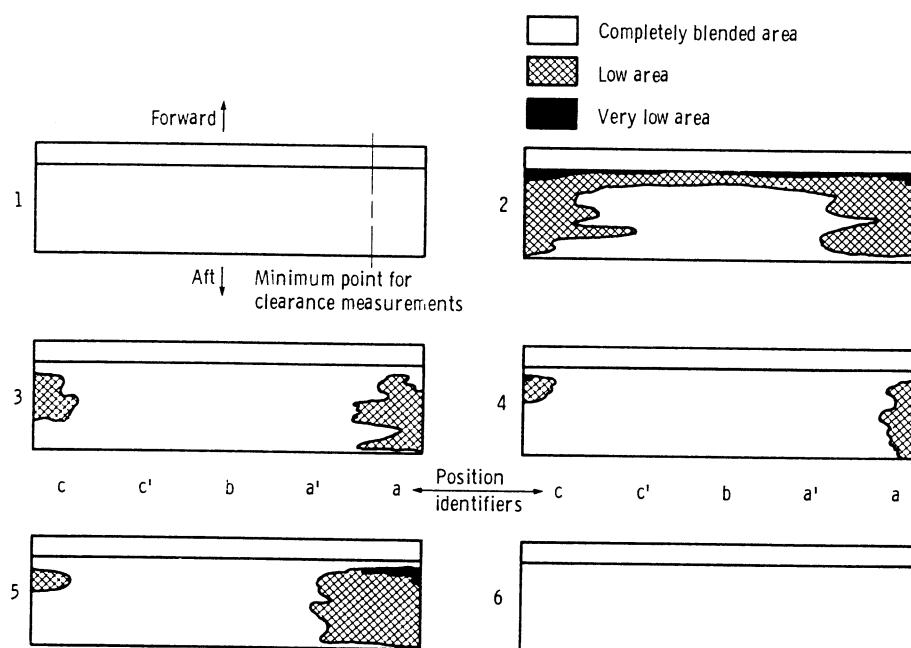
Figure 6. - Schematic of ceramic shroud thicknesses as installed in engine after final grinding.

- (f) A shiny area on the metal leading edge of shroud 1. The area was about 19.1 mm (3/4 in) long and extended into half the metal width between position indicators a and b. (See fig. 6.)
- (g) All other shrouds looked OK; additional sign of use was visible as overall darkening.

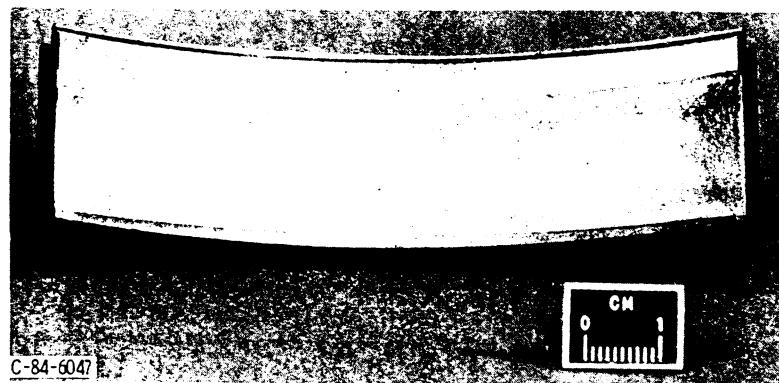
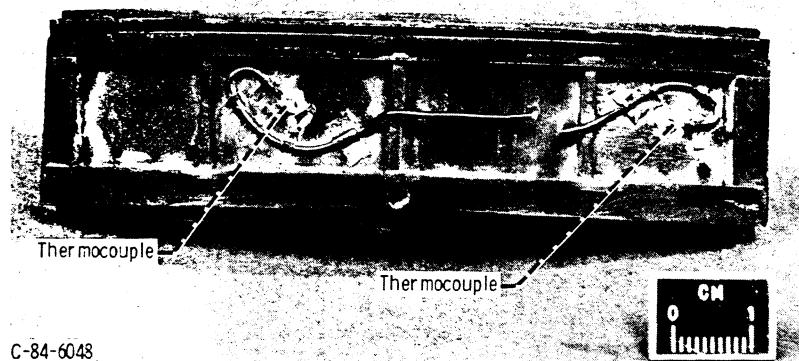
Figure 12. - Shroud segment after 1001 cycles.

A metallographic study (by General Electric Co. under contract to Lewis) found that, although the ceramic shroud specimen looked exceptionally good after 1001 thermal cycles (i.e., no detectable erosion or deterioration) in the engine test, a considerable amount of cracking was evident.

In this evaluation, one shroud (shroud 6) and a typical cross section were metallographically examined. The front and back surfaces of a typical shroud are shown in figure 12, which indicates a reasonably smooth surface without visible defects. Some slight erosion was evident, along with a small amount of 8-wt % yttria-stabilized zirconia ceramic darkening. Macroscopic observations (figs. 17 and 18) (at 32x) showed cracking in the bond coat region along the trailing edge (fig. 18(a)), which extends back into the ceramic flow path surface. Some ceramic cracking was also evident along the leading edge (fig. 17(b)), along with some surface microfracturing (fig. 17(a)). The right end of the shroud showed both vertical and bond-line cracking (fig. 18(b)).

(a) Hot-gas side.

(b) Backside.

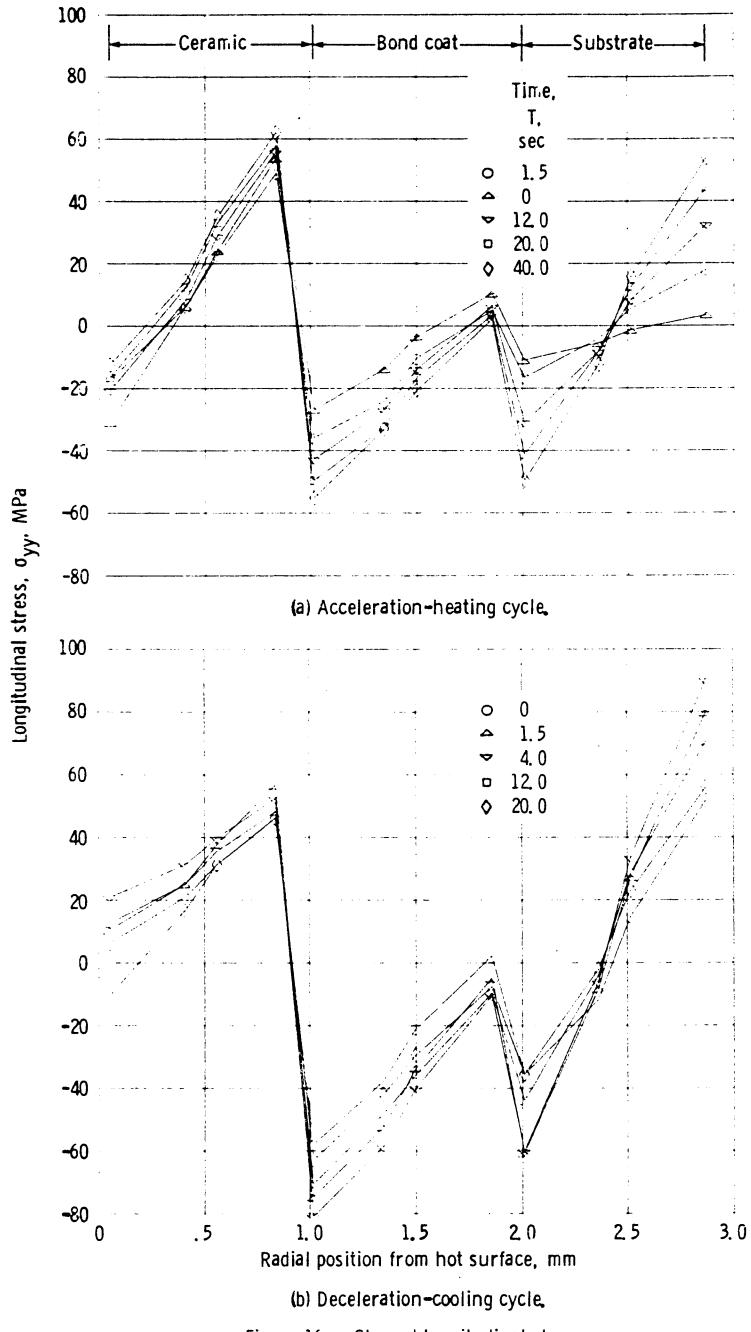
Figure 16. - Shroud longitudinal stress.

Using the thermal profiles generated by ADINAT, the radial, shear, circumferential, and longitudinal stresses within the shroud were computed. The longitudinal stresses are illustrated in figure 16 for the heatup and cooldown portions of the test cycle.

For this inelastic behavior case, radial and shear stresses are small, with the radial stresses negligibly small. The significant stresses for this case are the longitudinal and circumferential stresses, which are similar in magnitude. The longitudinal stresses are illustrated in figure 16 for the heatup and cooldown portions of the test. The longitudinal stresses are tensile at the surface during the cooldown portion of the cycle. These produce surface microcracking. Also, the stresses at the ceramic side of the bond coat and ceramic interface are always tensile, a condition leading to micro-cracking but not necessarily to material failure.

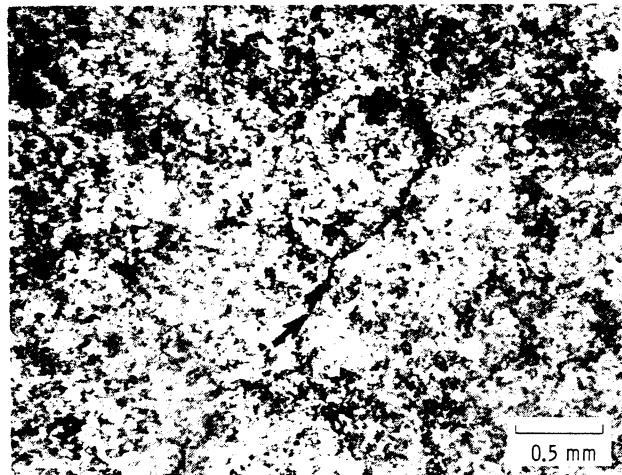
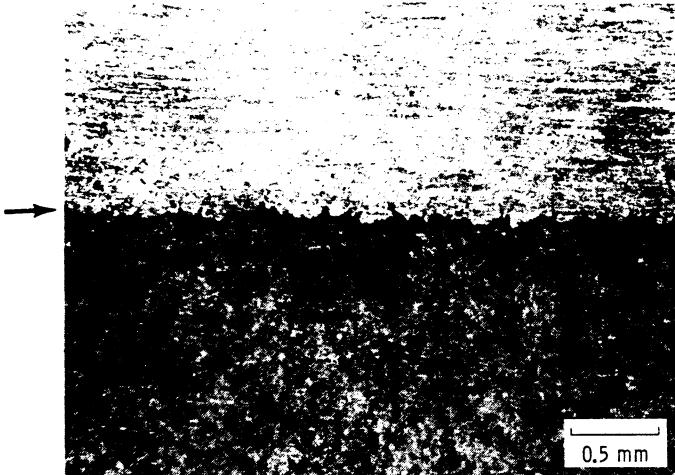
Figure 17. - Micrographs of ceramic shroud section - flow path and leading edge.

A metallurgical evaluation of a ceramic shroud segment is contained in appendix C. Highlights of the evaluation follow. A typical cross section through one of the ceramic shroud components shows that the ceramic coating thicknesses are not uniform. Figures 17 and 18 present micrographs of such a section. In figure 17(a) the section shows surface cracking. On an average the mud-flat cracks are about 1.5 mm (0.059 in) hexagonally spaced. Such large cracks have probably been preceded by microfracturing. Figure 18(b) indicates that the cracks tend to penetrate to the bond coat interface where cracking appears to either terminate or, in some instances, spread axially and perhaps circumferentially.

(a) Typical flow path crack.

(b) Ceramic crack leading edge.

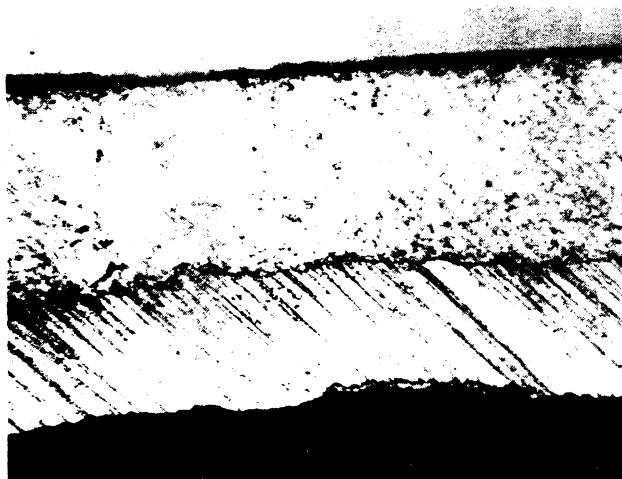
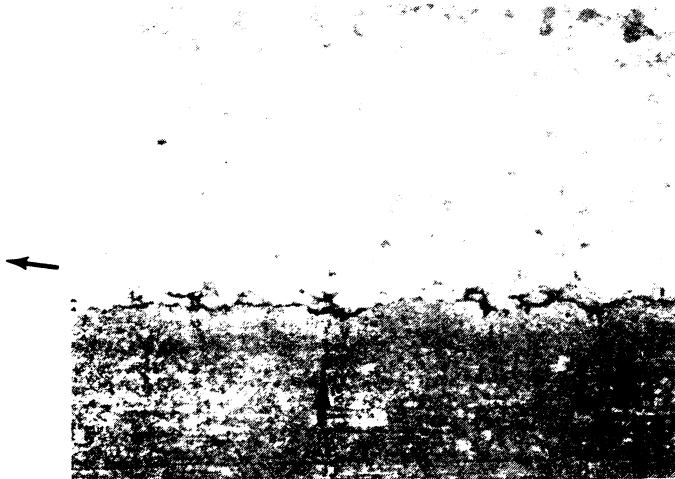
Figure 18. - Micrographs of ceramic shroud section - trailing edge and right end.

The degree of cracking around the outer perimeter was measured. Of the total perimeter length of 24.4 cm (9.6 in), 0.9 cm (3.6 in), or ~37.5 percent was cracked.

(a) Ceramic and frame crack trailing edge.

(b) Right end bond line and vertical crack.

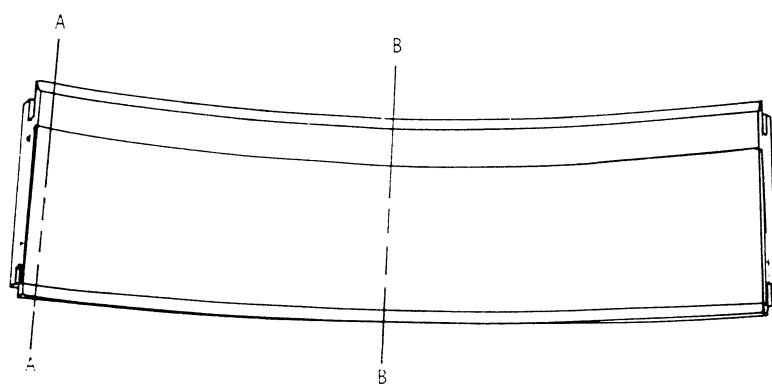
Figure 21. - Metallographic sectioning locations.

Pretest and posttest microstructures of the plasma sprayed coatings (yttria-stabilized zirconia and NiCoCrAlX) on the engine shroud segments were examined. (Section locations are given in fig. 21.)

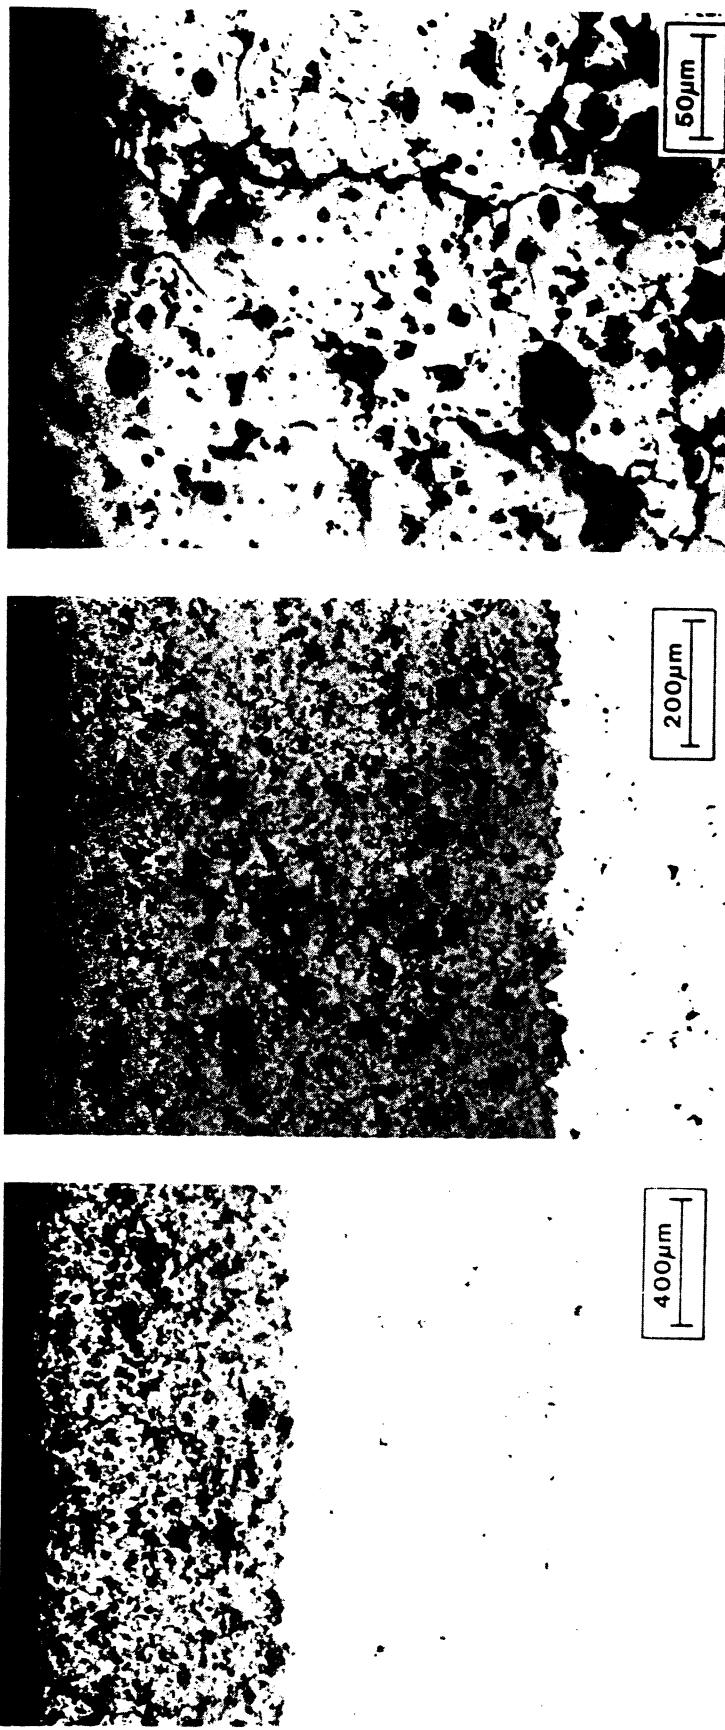
The pretest micrograph (fig. 22(a)) was examined on a quality control specimen that was not run in the engine. The micrograph reveals some vertical cracking which provides strain relief.

(a) Pretest microstructure; cross section B-B.
Figure 22. - Plasma-sprayed shroud seal. (See fig. 21 for cross-section positions.)

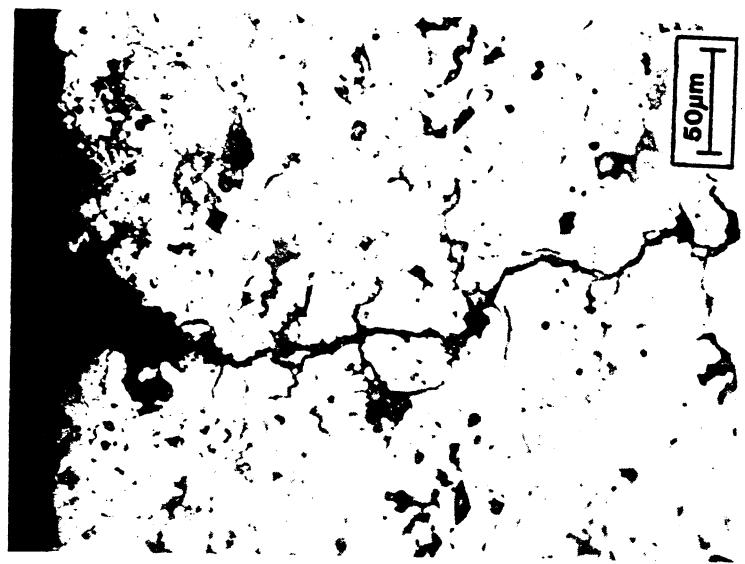
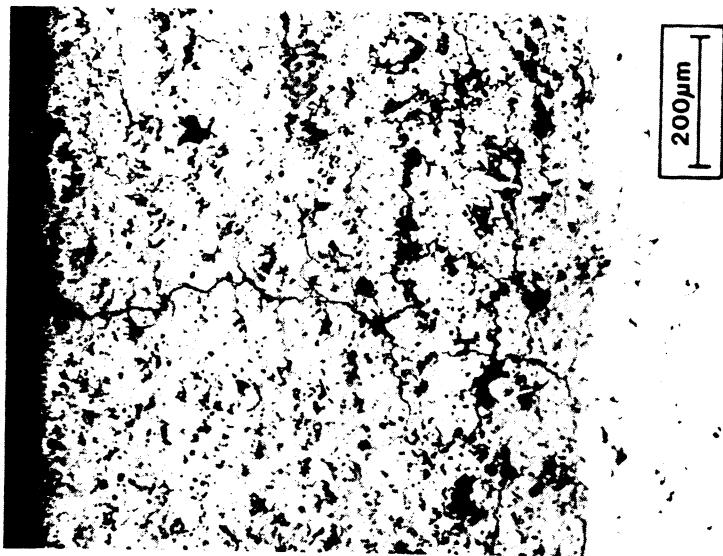
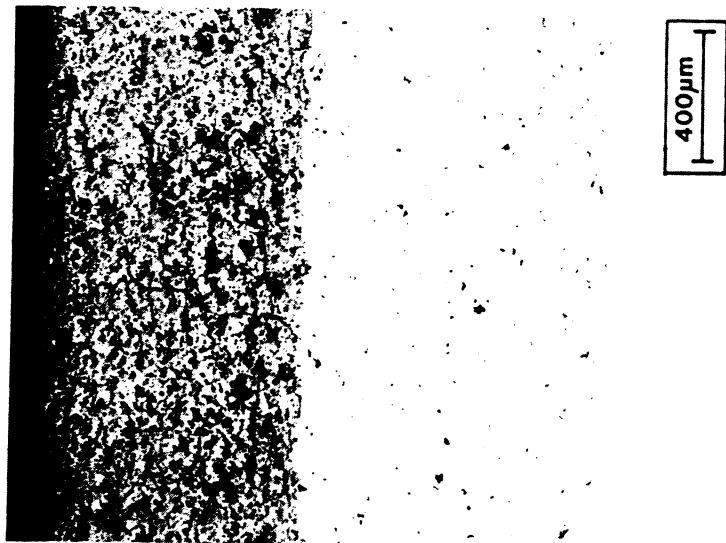
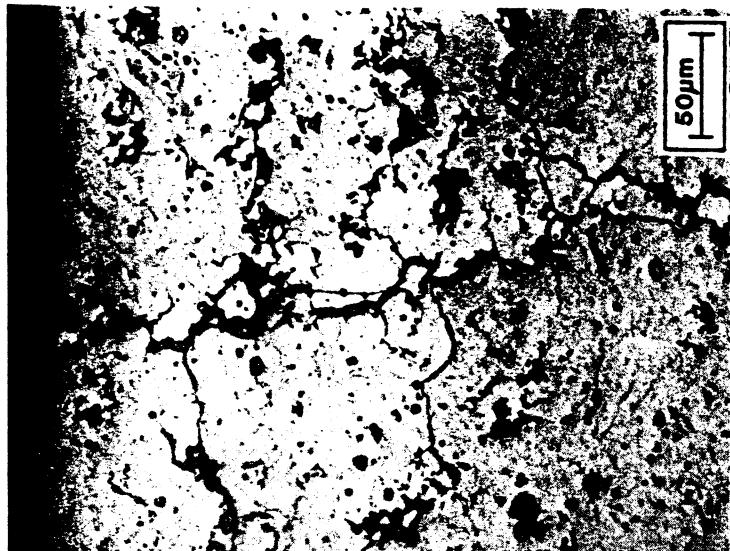
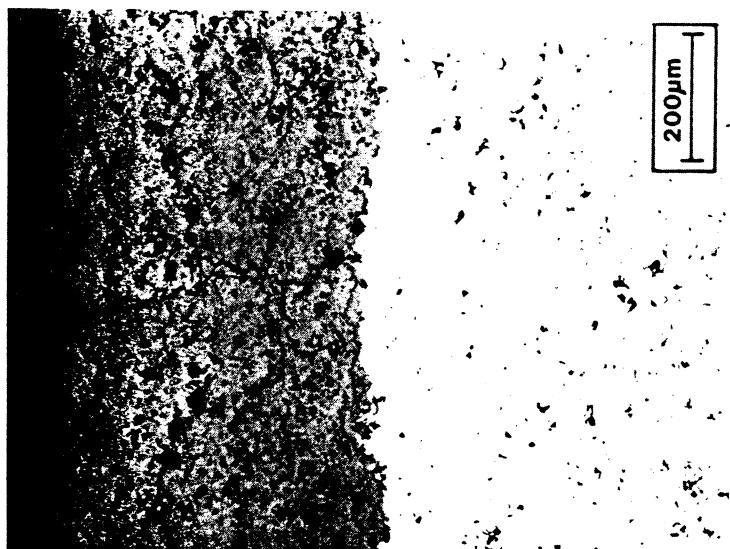
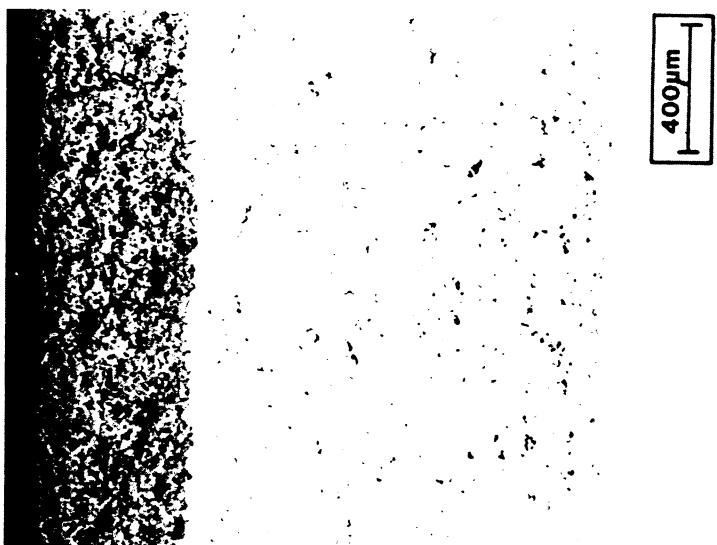
Figure 22. - Continued.

Examination of posttest ceramic coating microstructure (figs. 22(b) and (c)) revealed extensive segmentation, commonly called mud-flat cracking, and some local areas of lateral cracking and large porosity. Apparently, densification of the ceramic occurred. Caution must be exercised here, however, as observed microstructures are very dependent on metallographic polishing methods. The metallic bond layer exhibited considerable porosity, predominately due to pullout during metallographic polishing which was optimized to reveal the ceramic microstructure. The extensive porosity noted next to the leading and trailing edges was due to the geometry of the part not having been optimized for plasma spray coating. No evidence of any significant oxidation or β -phase (NiAl) depletion on the NiCoCrAlX bond layer was noted. Variations in the thickness of the metallic and ceramic layers found in sections AA and BB are due to impression of the process.

(b) Posttest microstructure; cross section A-A.

(c) Posttest microstructure; cross section B-B.
